Global Clinical Case Contest 2021-2022

Introduction to the case

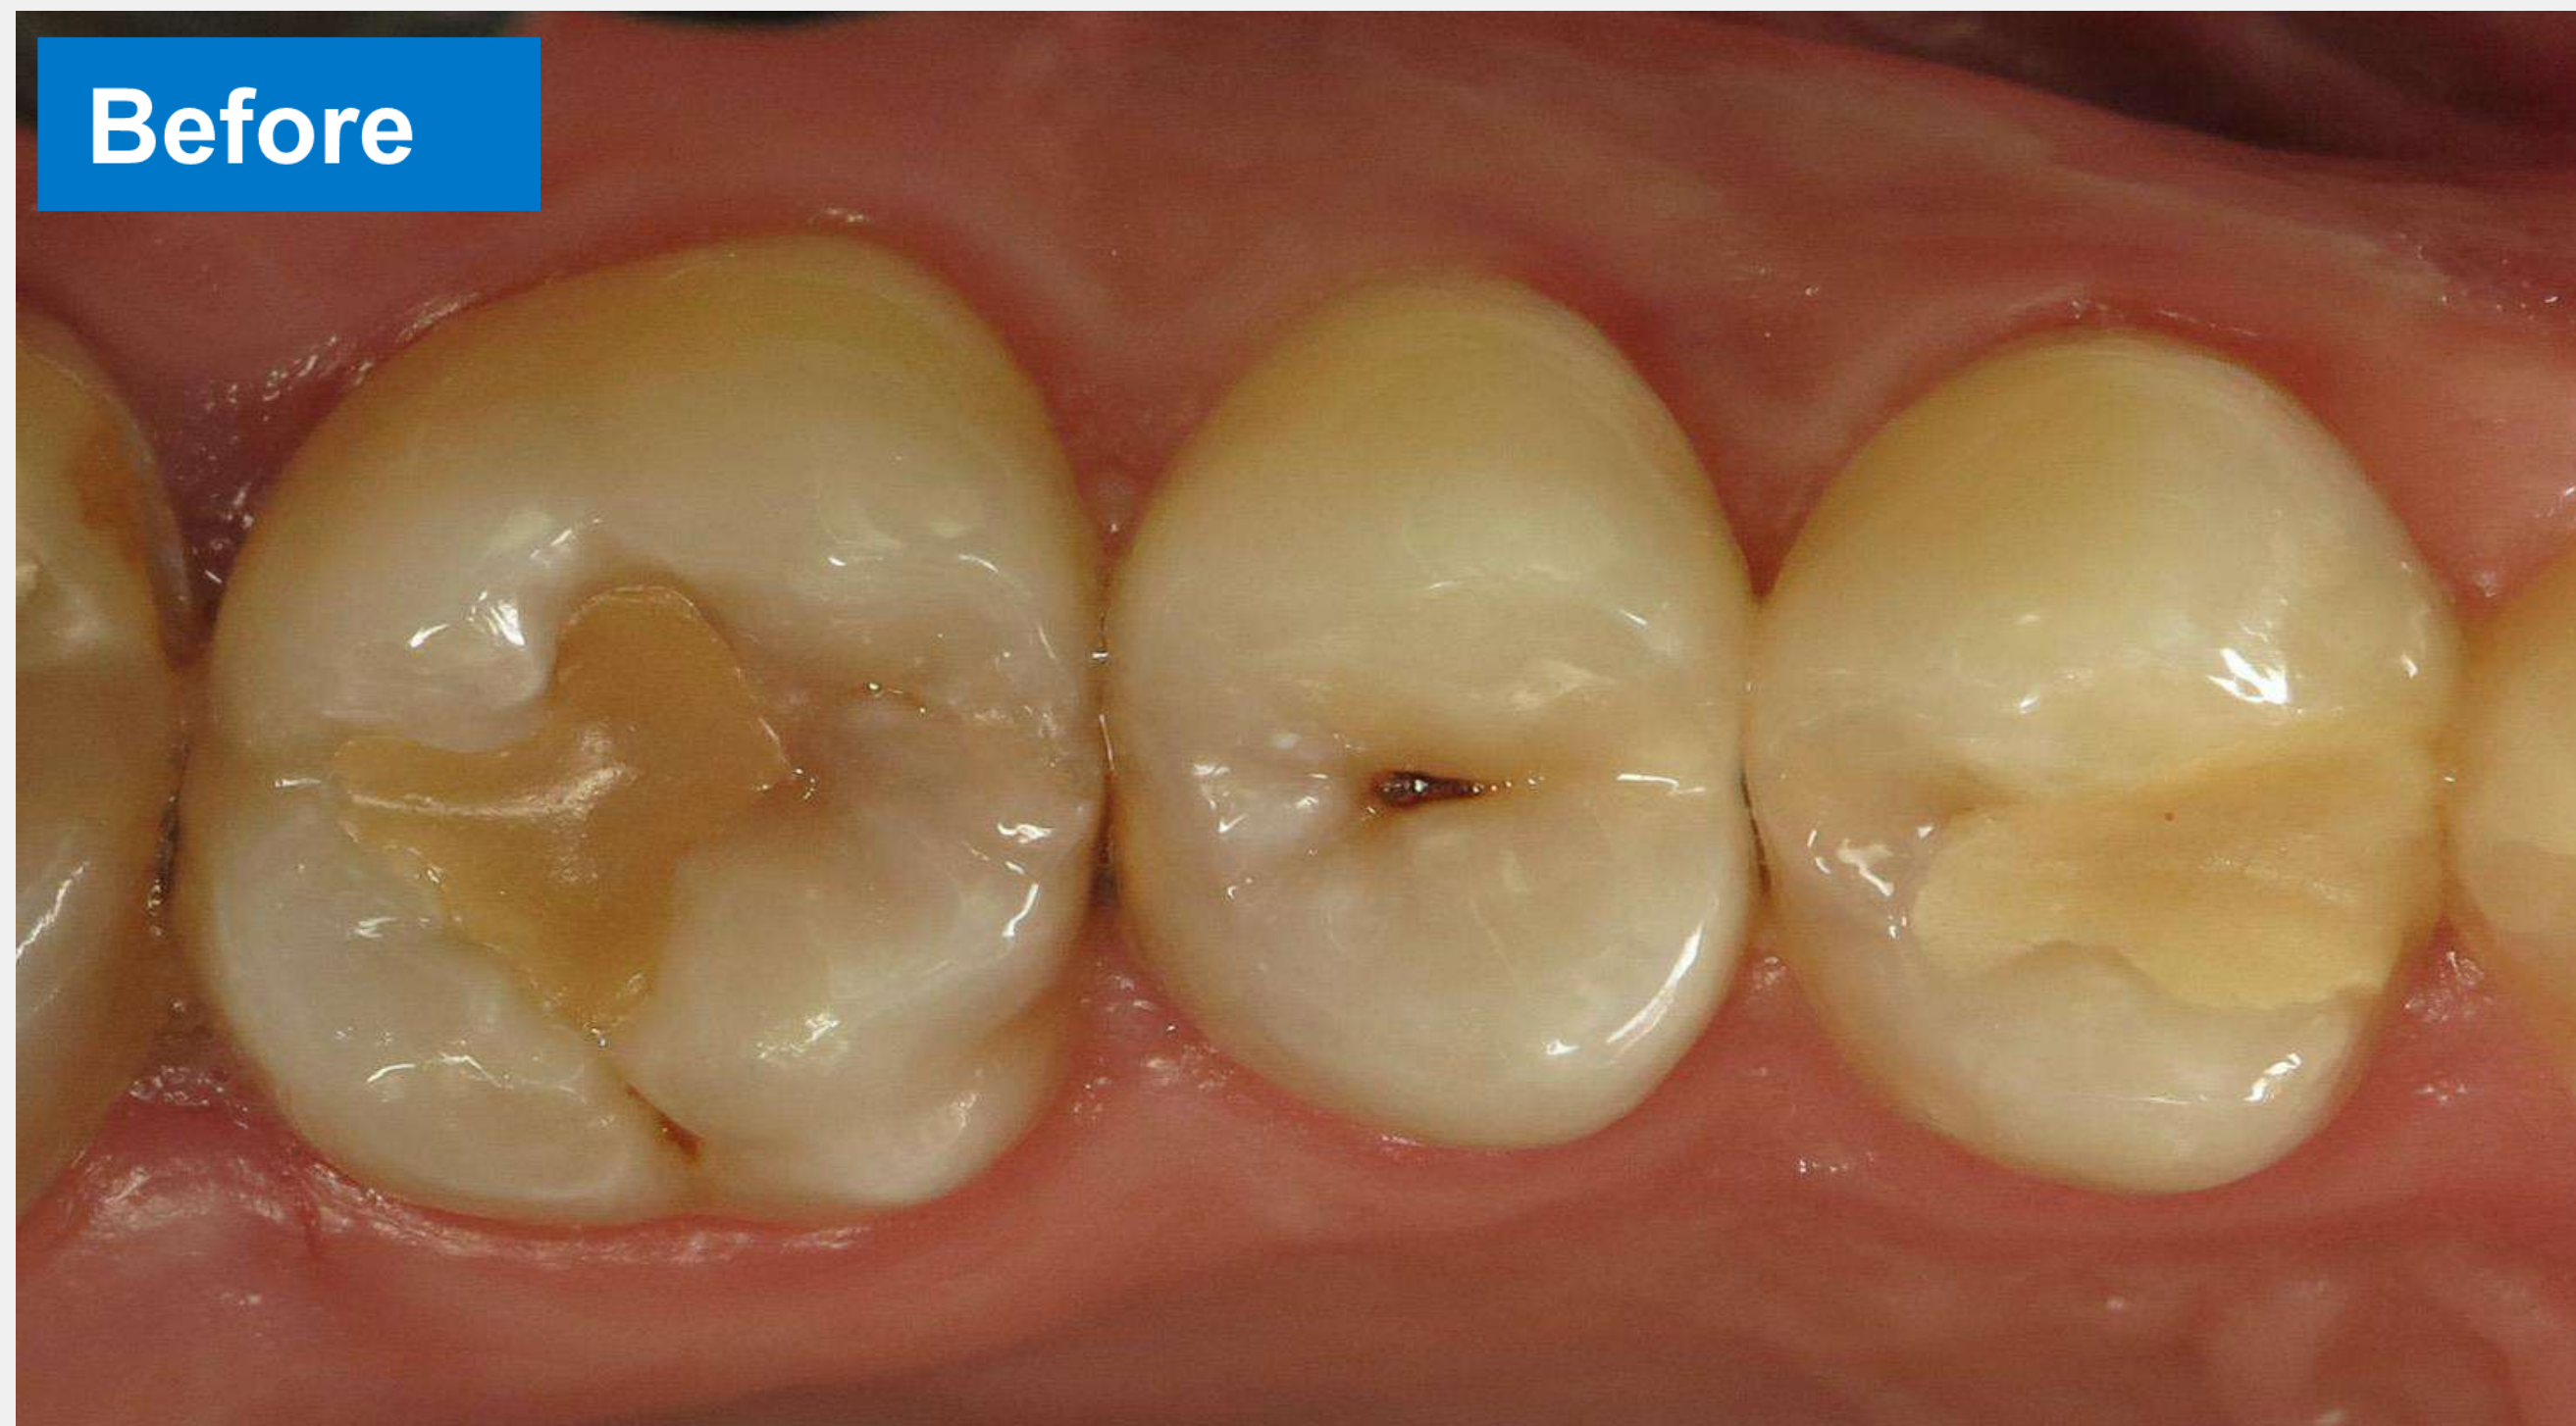
Pre-operative intraoral view showing old restorations and a caries

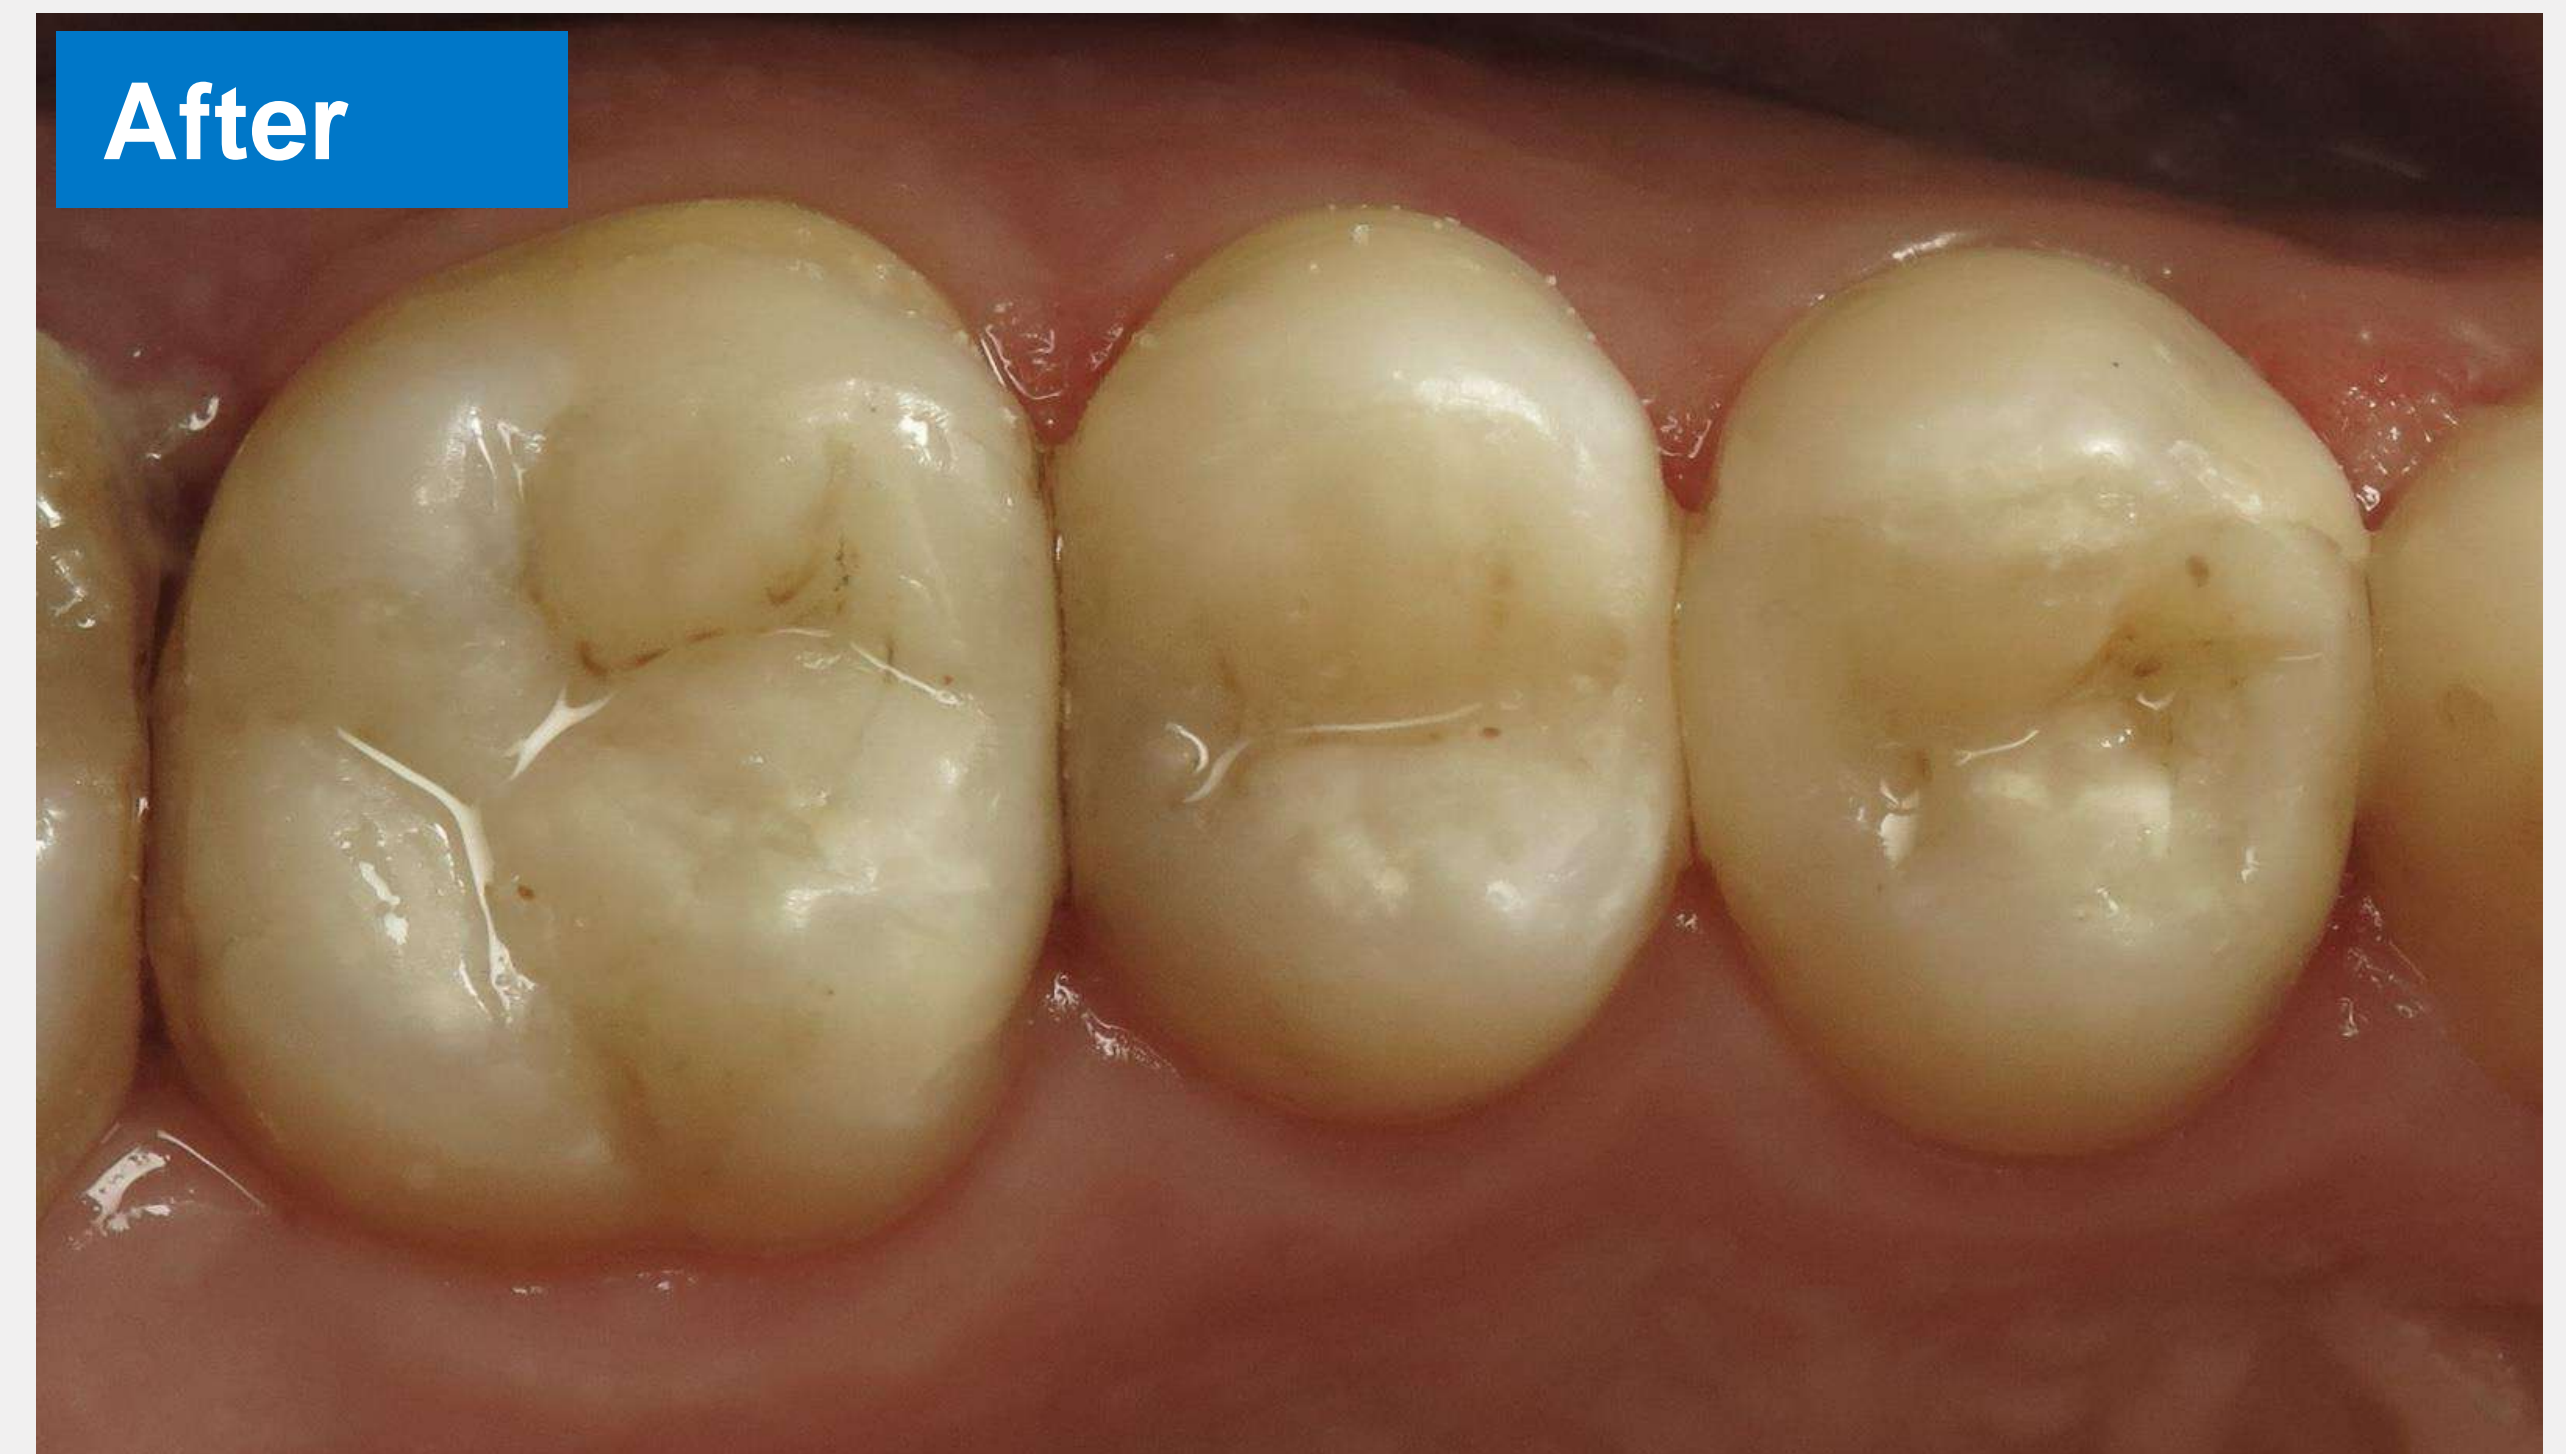
Post-operative intraoral view showing the final direct restorations with Dentsply Sirona restoration materials

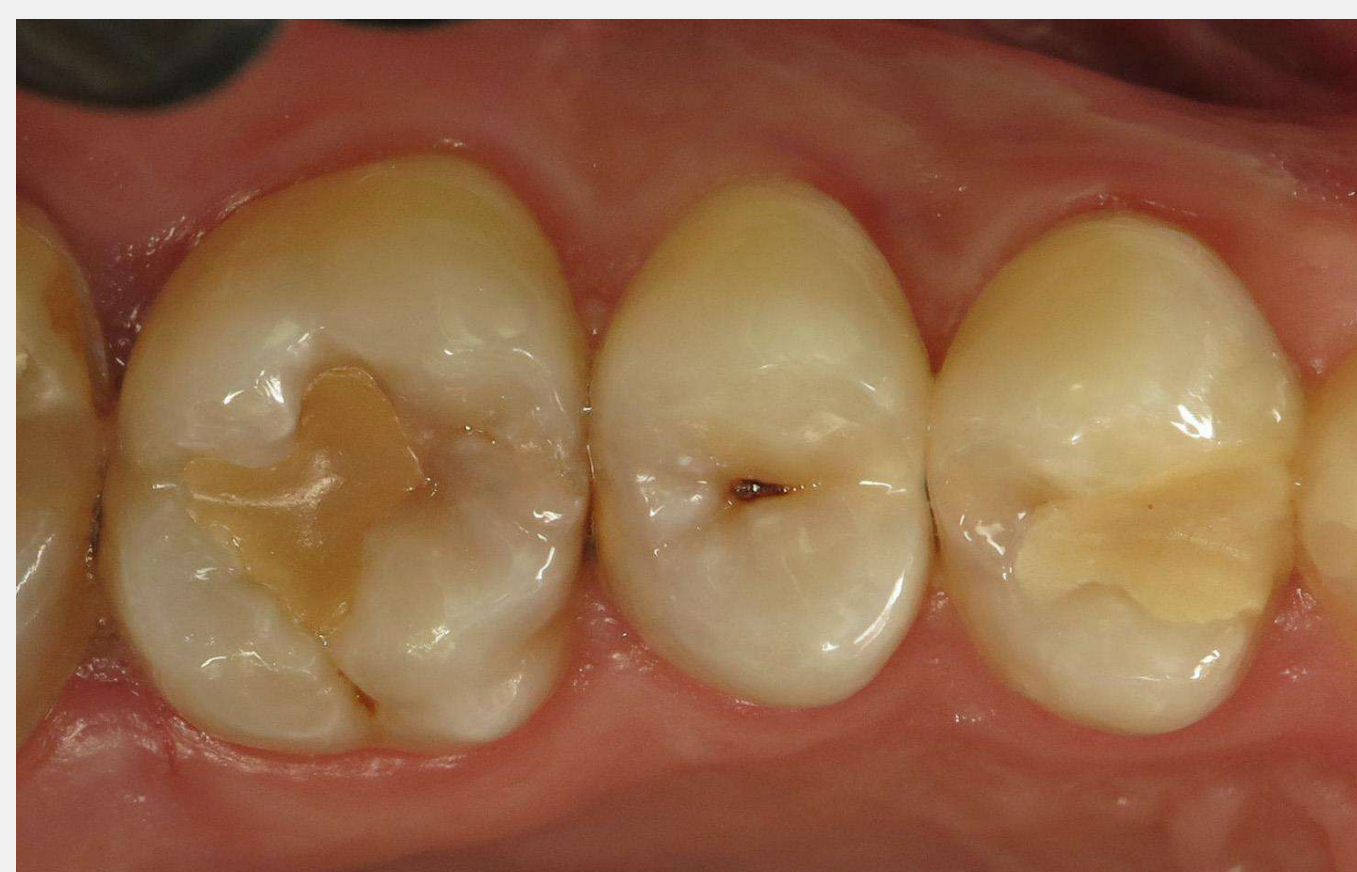
Step 1. Pre-operative view
Pre-operative occlusal view

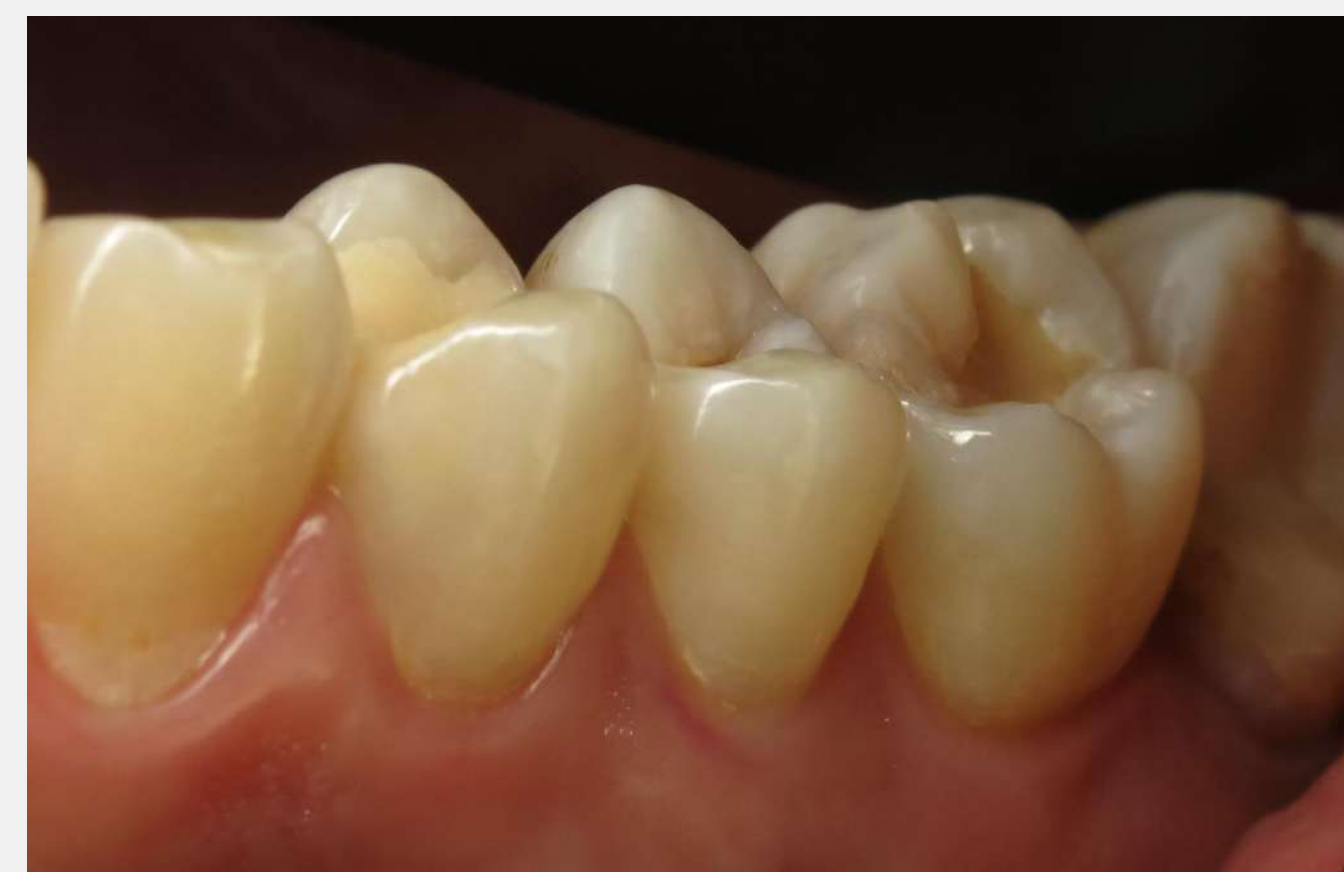
Step 2. Pre-operative view
Pre-operative vestibular view
